FIELD INSPECTION REPORT

Drainet Name	Marintein Valler Dingling	luonostor.	Matth and Crant
Project Name:	Mountain Valley Pipeline	Inspector:	Matthew Grant
Inspection Date:	Wednesday, August 26, 2020 AR-MLV26	Project Contact:	Brian Clauto
Spread G: Montgomery	MP220.8-223.1 ATWS1487	Weather:	Dry
ACTIVE STAGE OF CONSTRUCTION: (Check all that apply)			
☐ Tree Felling	☐ Clearing/Grubbing ☐ Gra	ding 🗌 Trench	ning Stringing/Welding
☐ Lowering/Backfilling	☐ Final Grading ☐ Tem	np. Stabilization Perm.	Stabilization 🗵 Dormant
			Yes No N/A
Are controls installed and implemented in accordance with the approved erosion and sediment control plan and stormwater management plans?			and 🛛 🗆

FIELD INSPECTION PHOTO LOG

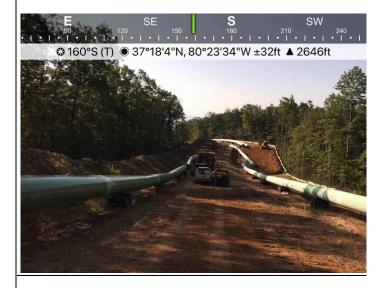
Figure 3: Near MP 221 straw stockpile and stabilization work was being conducted.
